May 16, 2007 Update Jennifer Talken-Spaulding Cultural Resource Specialist, NPS

September 24, 2007 Update Jennifer Talken-Spaulding Cultural Resource Specialist, NPS

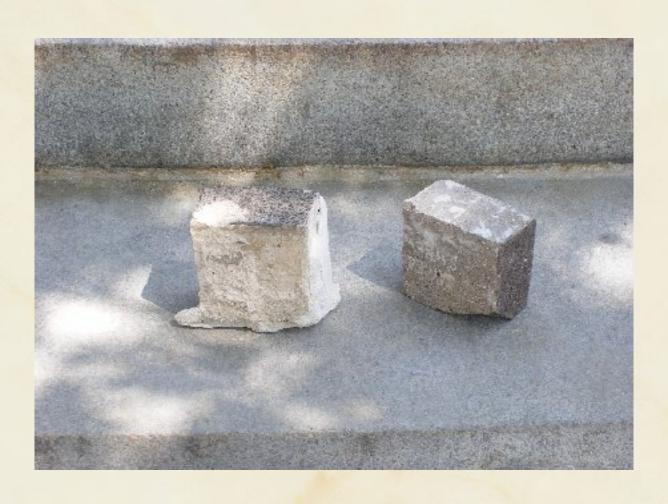
. . . and sometimes cut for reuse, to get the correct color and size match.

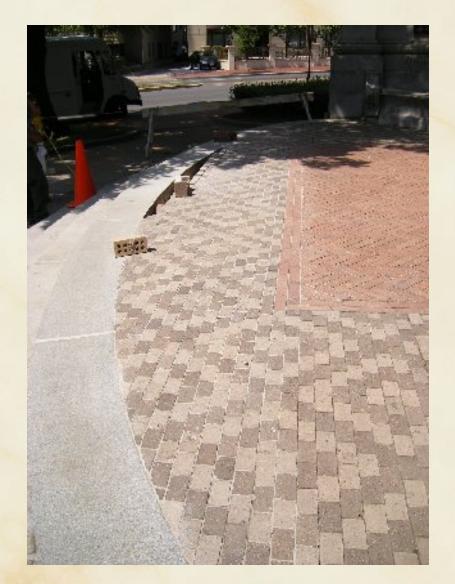
Then they were relaid in the existing pattern.

The reset top steps are solid and have already been repointed. The bronze is still looking very good after the cleaning/waxing from last year.

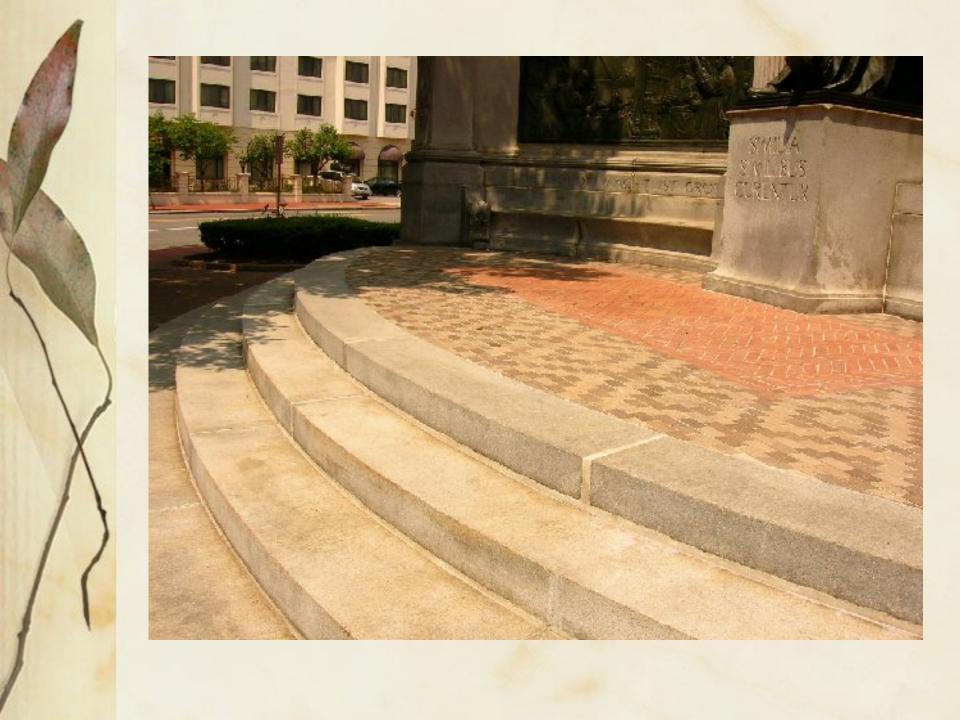
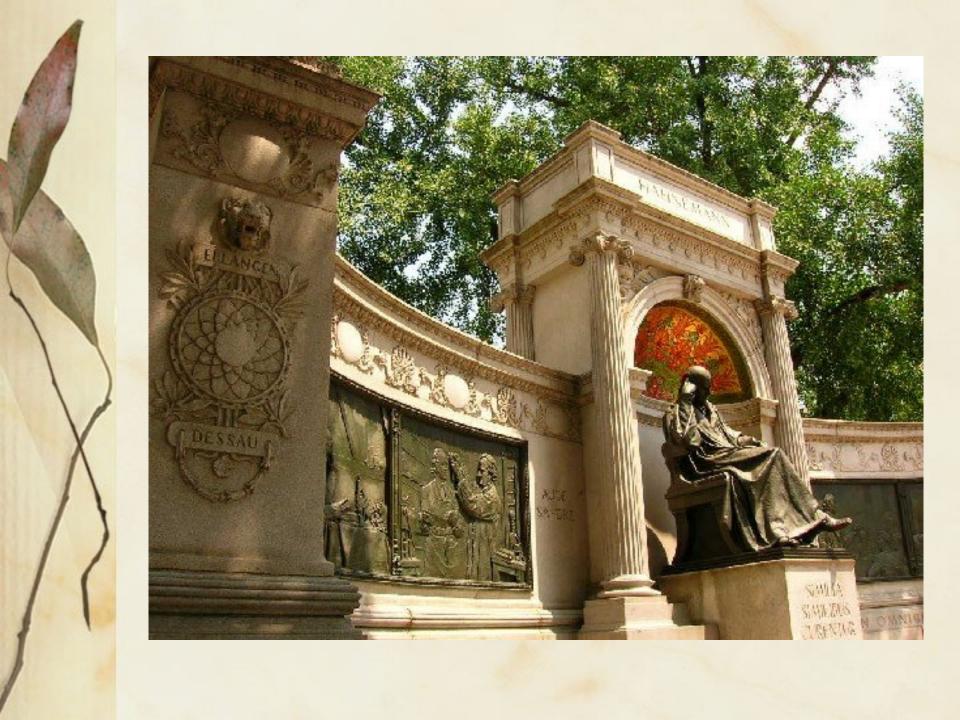
She reports that the plaza and steps at the base of the Hahnemann Monument have been completed and they look very good. The crew cleaned and repointed around the entire brick plaza to finish the job.
